# HOME INSPECTION REPORT

**Inspection Date:**

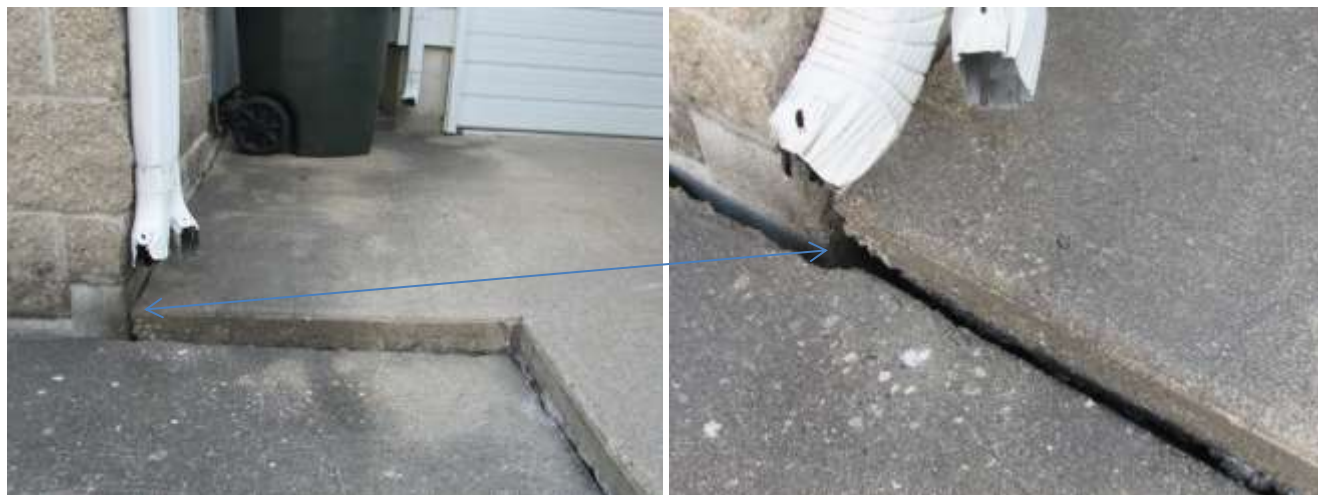
Recommend sealing this crack to keep water from softening soil holding up the concrete here.

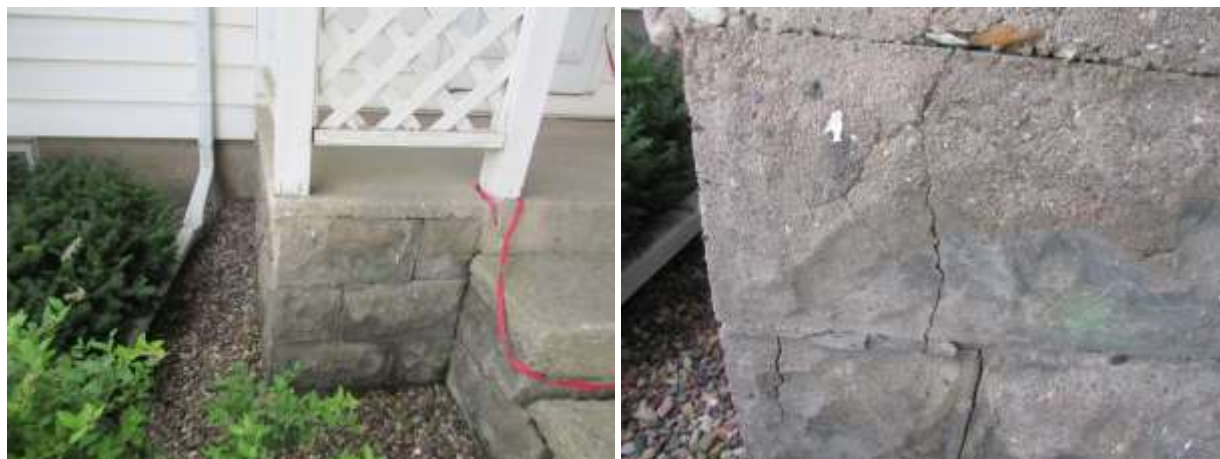
Some of the block holding up the porch roof and floor had some cracks. Recommend sealing these cracks. Mor Flexx would be an example of a product that is used for this purpose.

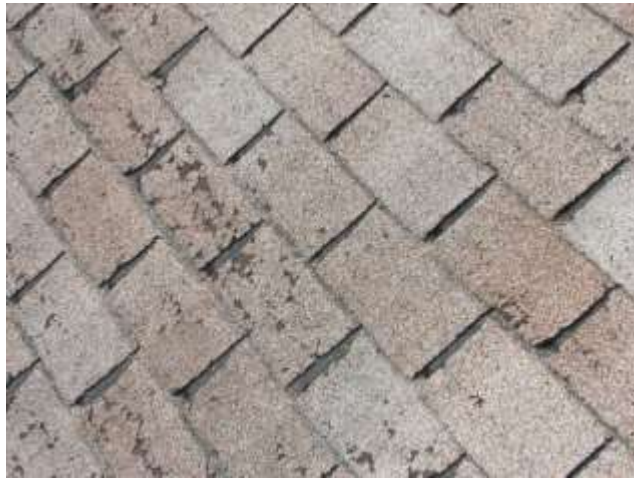
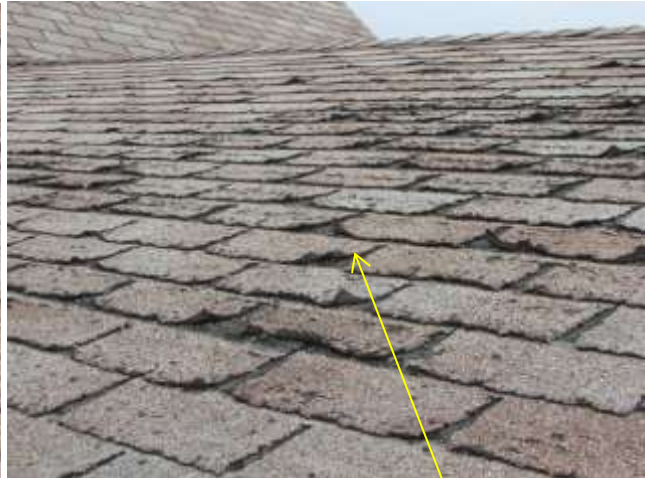
There were two areas of shingle deterioration. They were both in the southeast quadrant of the garage roof. Plan on replacing the shingles within five years or so.

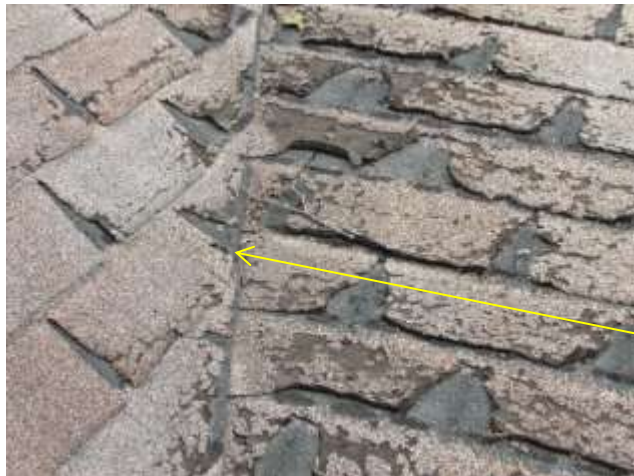
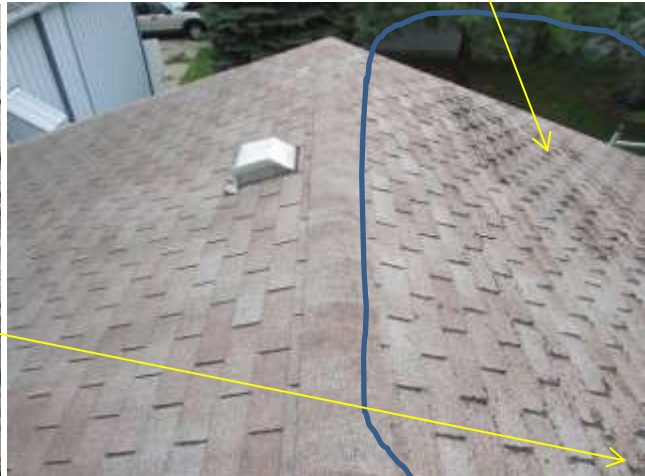
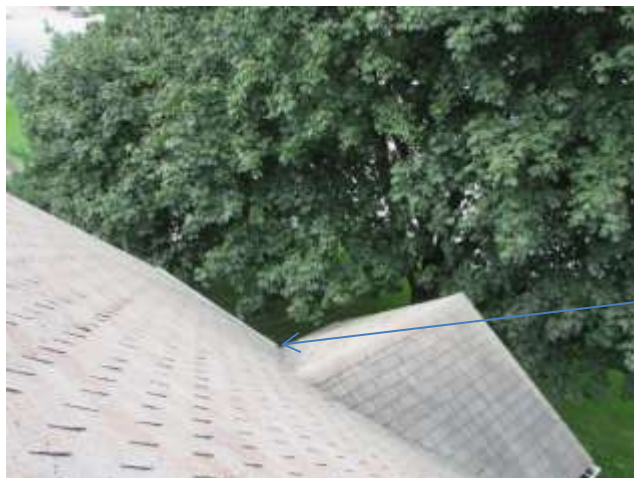
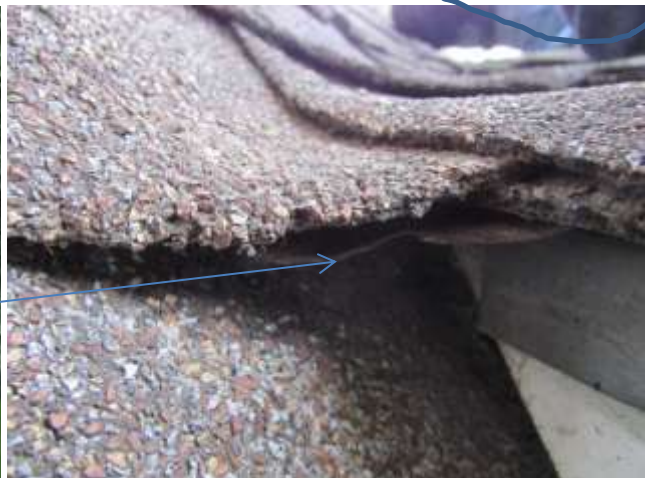
The Maple tree will want to contribute to the west gutters. Keep gutters clean. The valleys both have a metal under-flashing. Satisfactory!

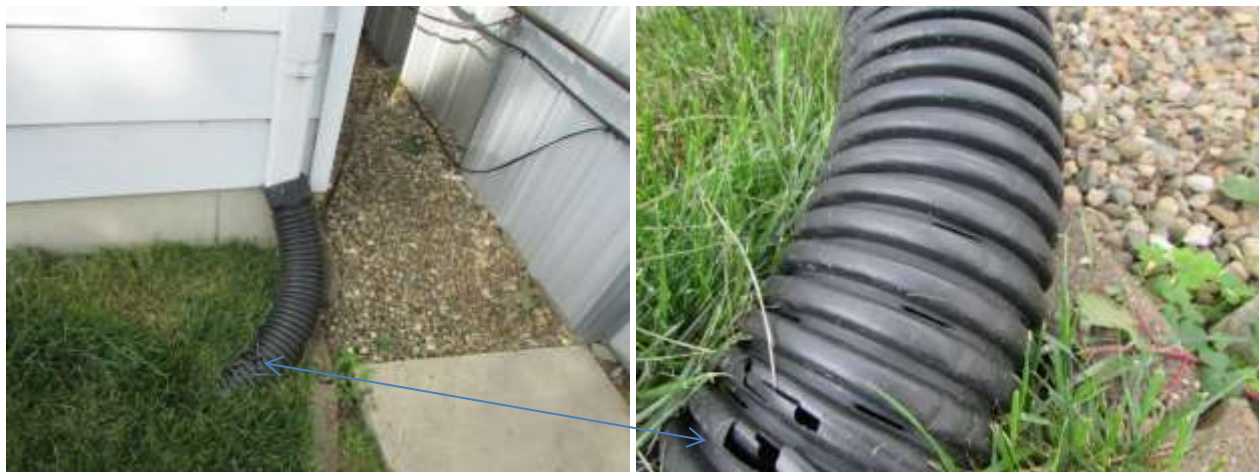
The downspout extension on the northeast corner of the garage is perforated tile. This is not recommended for moving water. However, it would appear that the tile discharges here, at the southeast corner of the home, and it is solid tile by that time. Note in the lower right photo that there is water resting in the bottom of the tile. This may indicate that the tile converts from drain tile to solid tile somewhere along its length. As long as garage water is moved at least six feet from the foundation, I'll call the tile satisfactory.

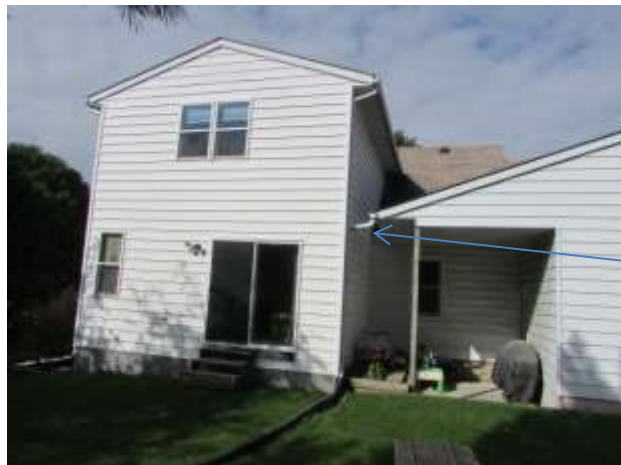
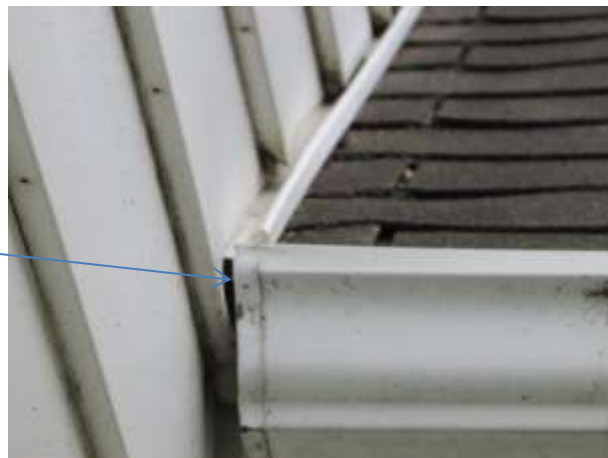
Recommend sealing the bottom ends of the j channel to keep water out of the wall.

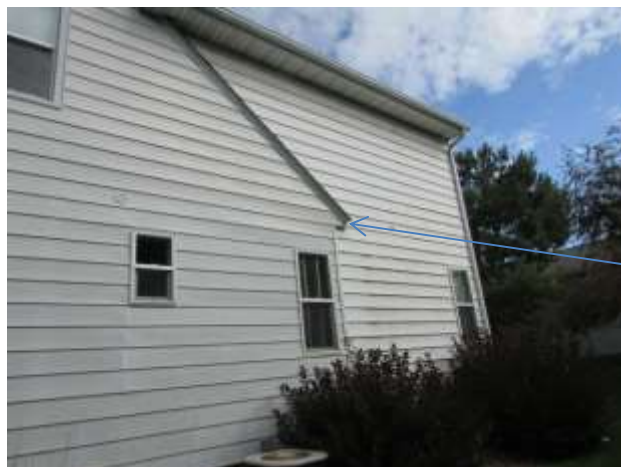
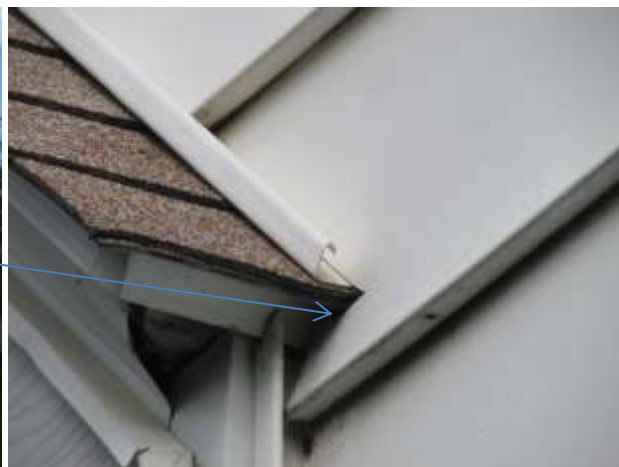
**TRIM, SOFFIT, FASCIA, FLASHING**

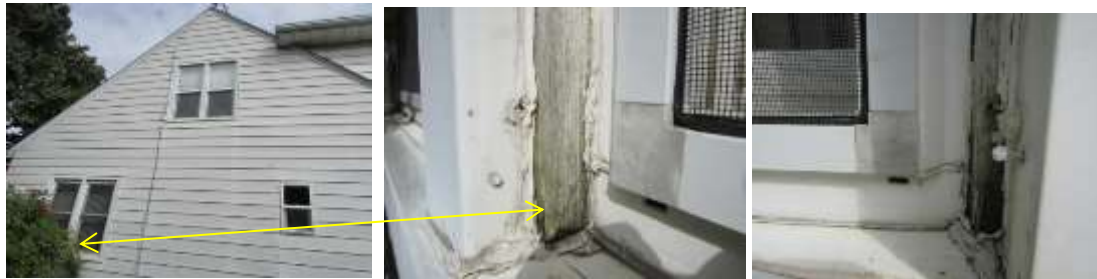
- Condition:**     Satisfactory     Marginal     Poor  
 **Recommend around windows/doors/masonry ledges/corners/utility penetrations**

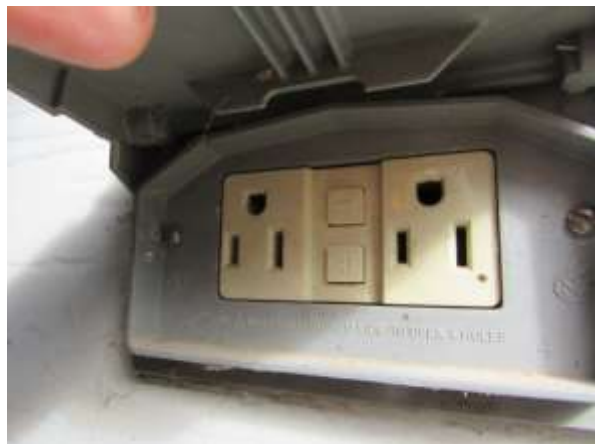
*The GFCI mechanism did not trip in the west garage exterior outlet. Recommend replacing this GFCI outlet. Cycle GFCI trip mechanisms about monthly to keep them limbered up.*

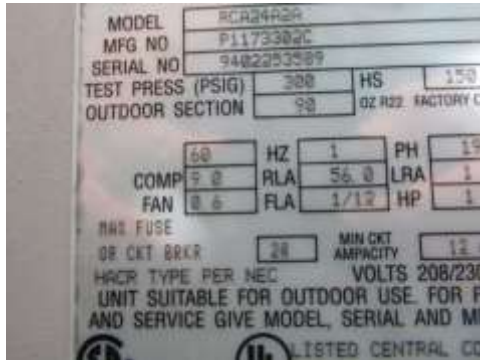
Brand: **Amana**                                      Model #: **RCA24A2A**                                      Approximate age: **22** yrs.  
**Outside Disconnect:**  Yes     No    Maximum fuse/breaker rating: **20** Amp                                      Fuses/breakers installed: **30** Amp  
**Level:**                                       Yes     No     *Cabinet/housing rusted*                                       *Improperly sized fuses/breakers*  
**Condenser Fins:**     *Damaged*                                       Need cleaning                                       *Damaged base/pad*  
**Condition:**                                       Satisfactory     Marginal                                       Poor

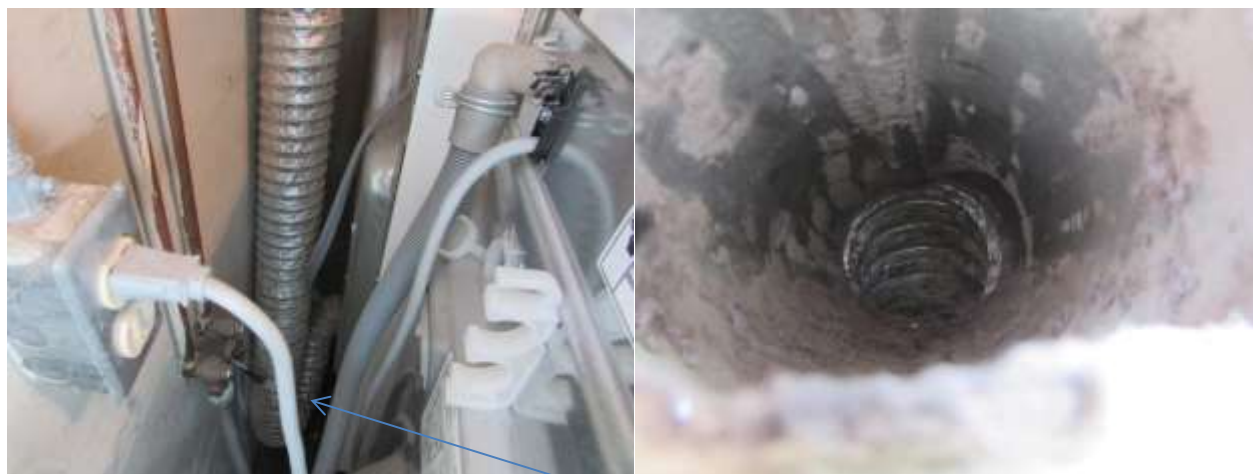
Remember that corrugated flex duct is a lint trap of its own. This U will be a probable air passage restriction. Recommend cleaning duct periodically to assure good drying times.

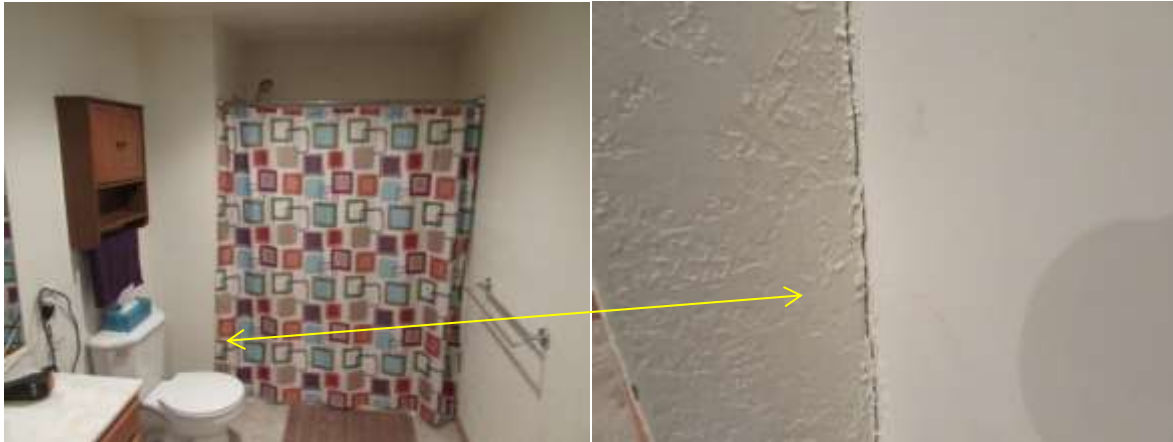
Recommend sealing this edge to keep moisture out of the wall.

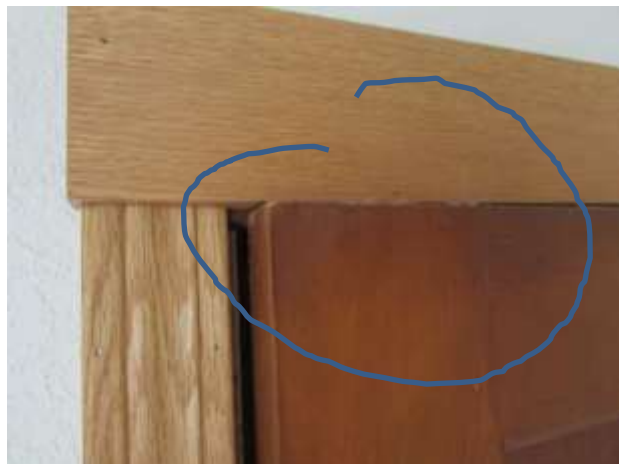
**GENERAL COMMENTS**

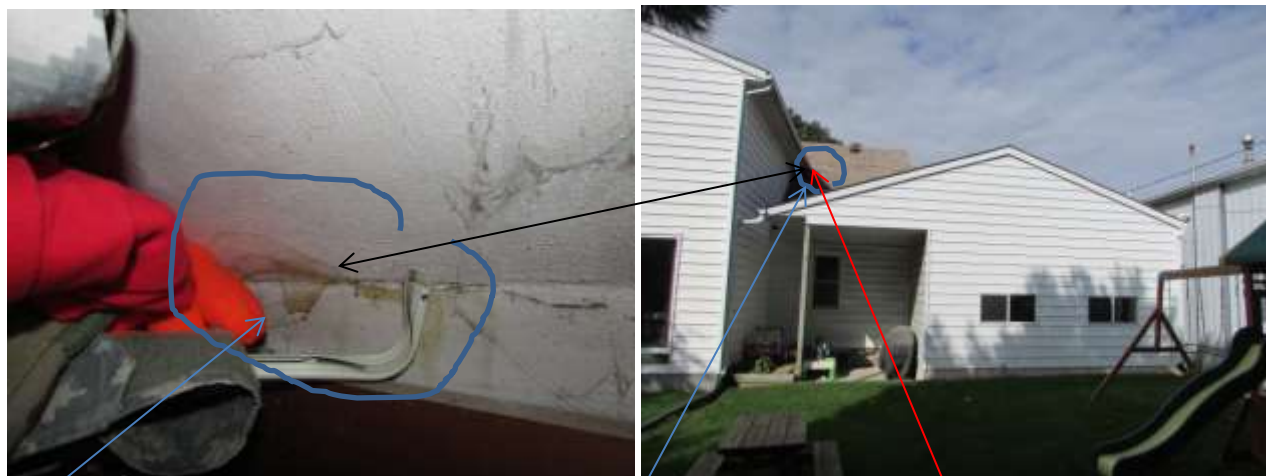
This little water stain is in the closet off the bedroom hallway. It is approximately right here on the roof. When the roof is re-shingled, make sure roofer pays attention to this area right here, so that water that's coming down the valley above doesn't feed under the shingles on the east slope.

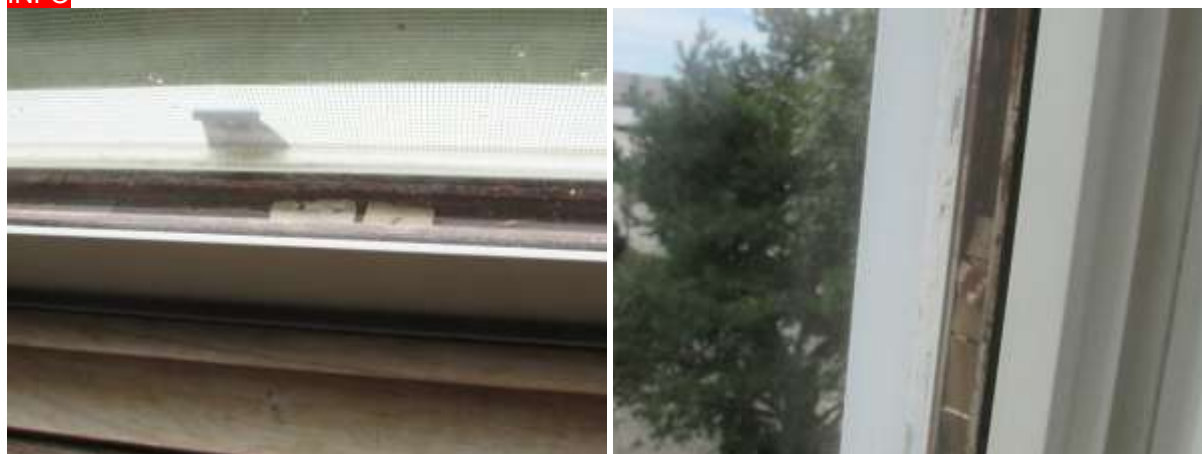
Two windows in this room had lost their two-pane-window seal. Recommend replacing these windows.

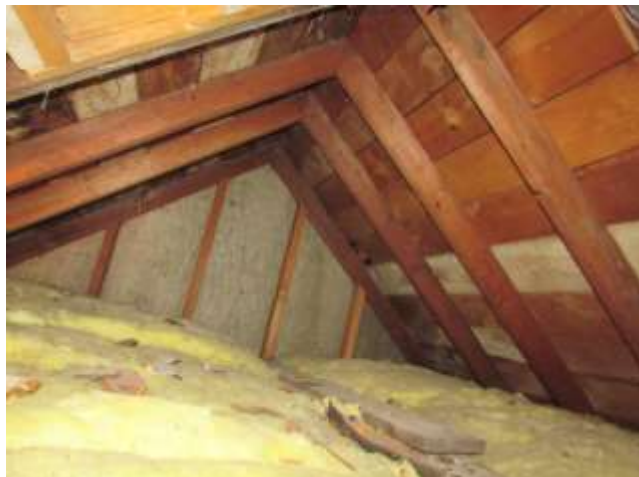
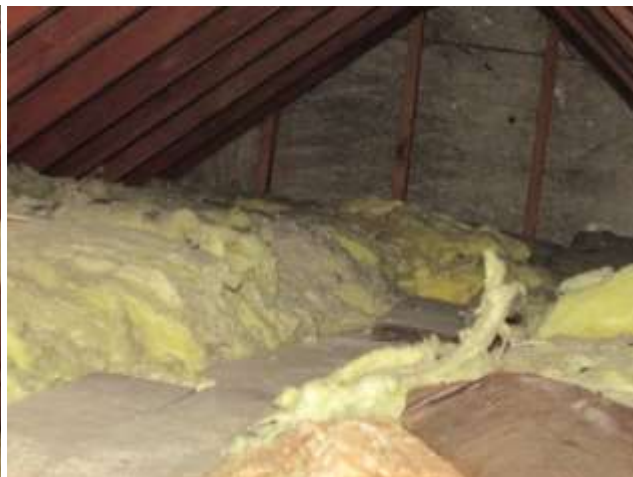
Fiberglass insulation in the older part of the house

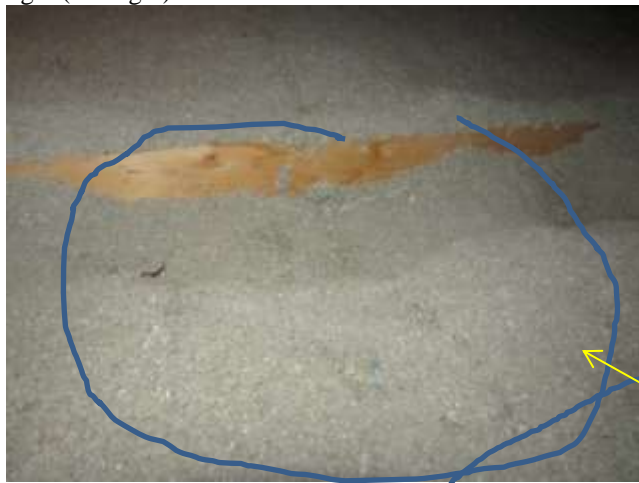
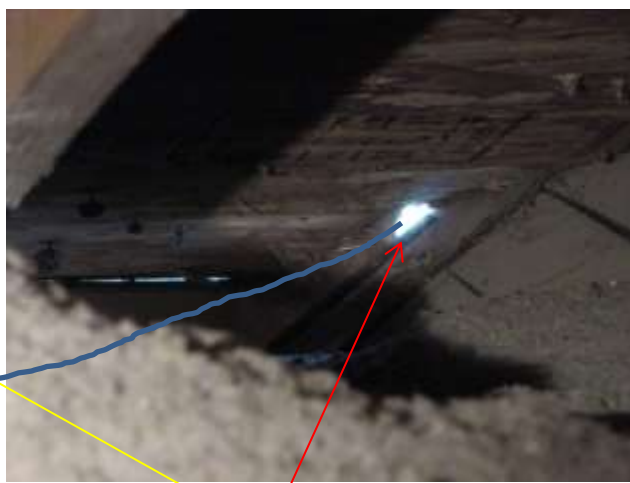
There is one area, near the scuttle hole hatch (which had no insulation on it) that has limited insulation. Recommend insulating this area and the attic hatch that is in the bathroom.

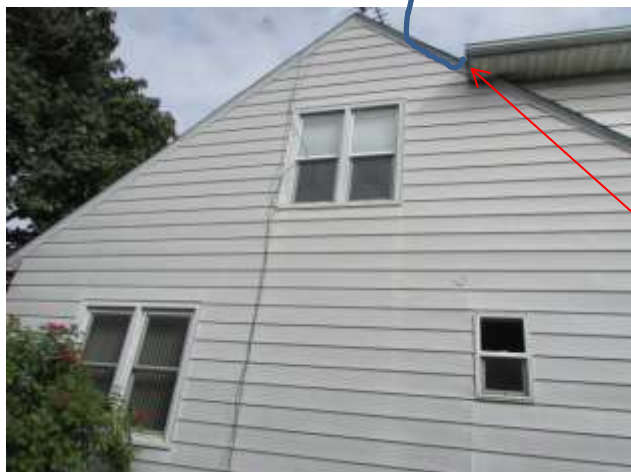
This hole is located right here. It is big enough for bats, though I saw no evidence of them. Recommend sealing this hole.

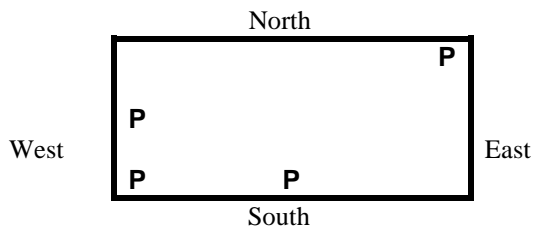
- FLOOR** **Material:**  Concrete  Dirt/Gravel  Not visible  Other  
**Condition:**  Satisfactory  Marginal  Poor  Typical cracks

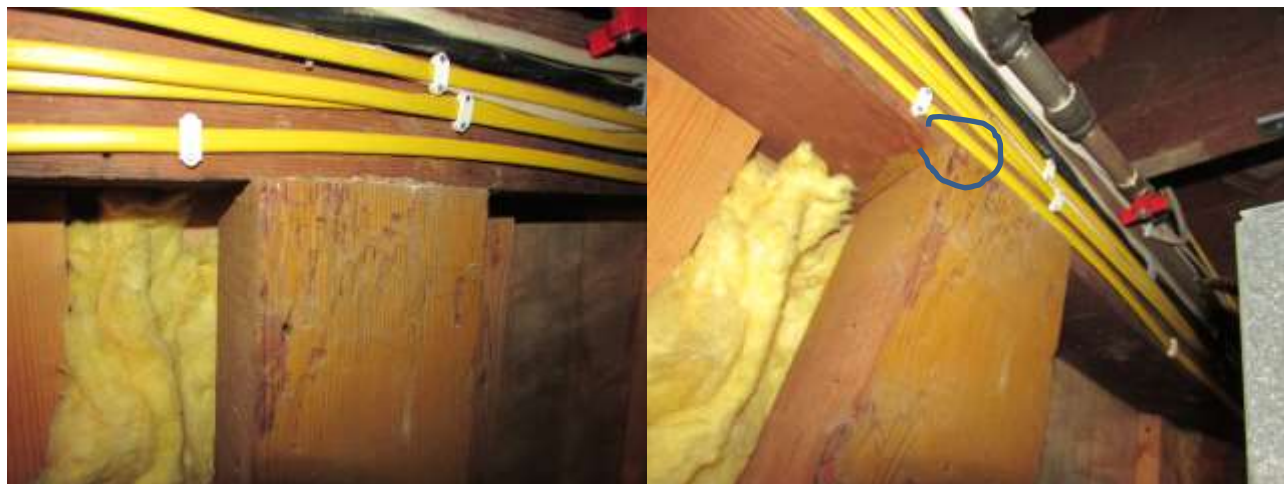
- Material:**  Steel  Wood  Block  Concrete  
 Not visible  
**Condition:**  Satisfactory  Marginal  Poor  Stained/rusted

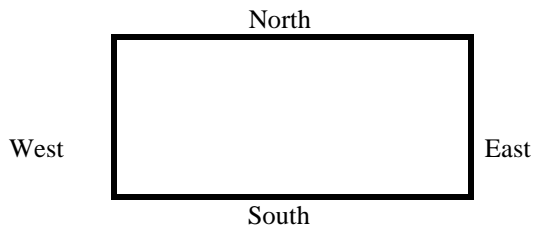
- P = Paneling
- D = Drywall
- S = Storage
- O = Other
- C = Crack(s)
- M = Monitor
- E = Evaluate

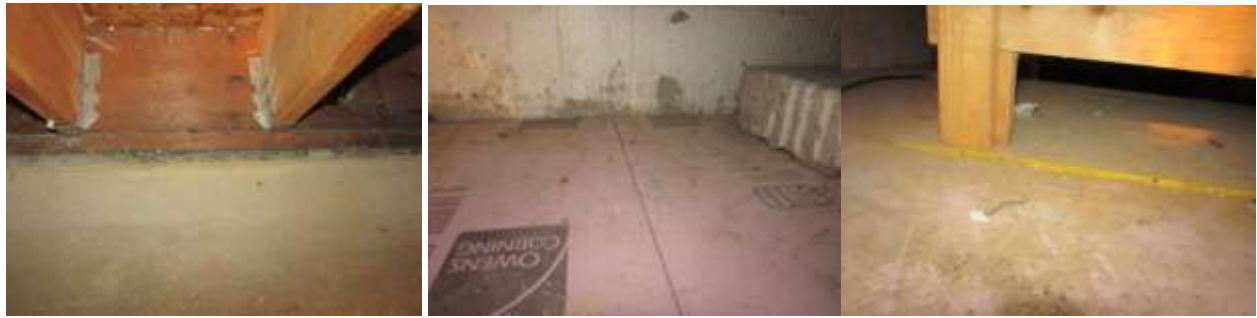
The addition was supported with joist hangers, attached to a rim joist which sat on the old foundation on the west and a new one on the east. The walls and floor were insulated. The hot tub sat on OSB sheathing to spread the load out over the insulation.

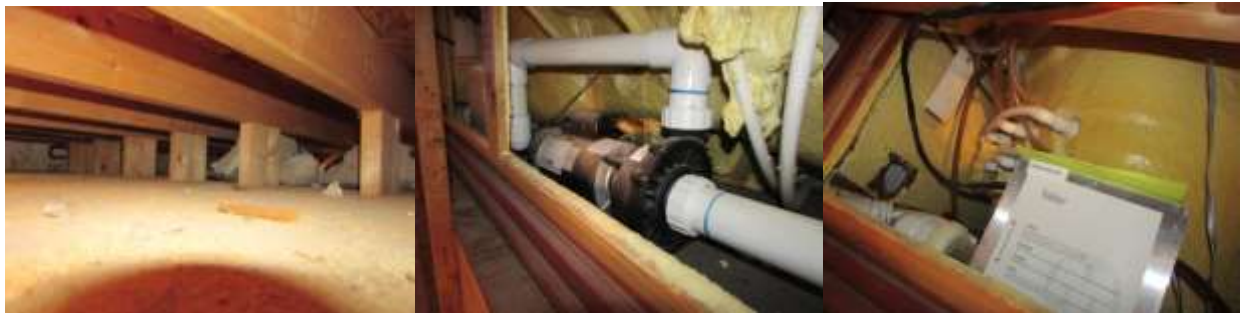
The hot tub was supported by a wooden framework. The pump was on the far side from the door, with the valve brain located near that. I did not find a way to drain the tub!

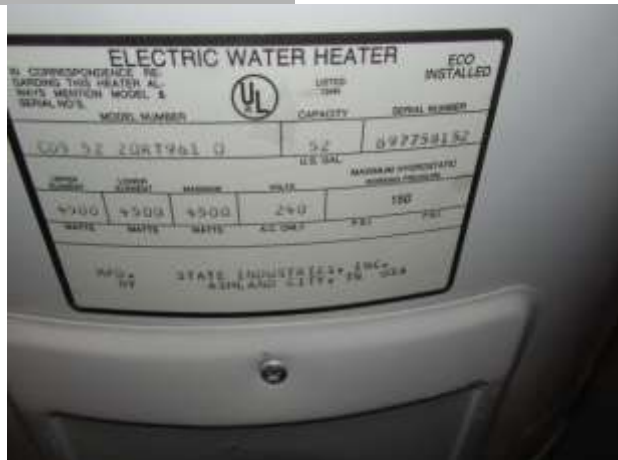
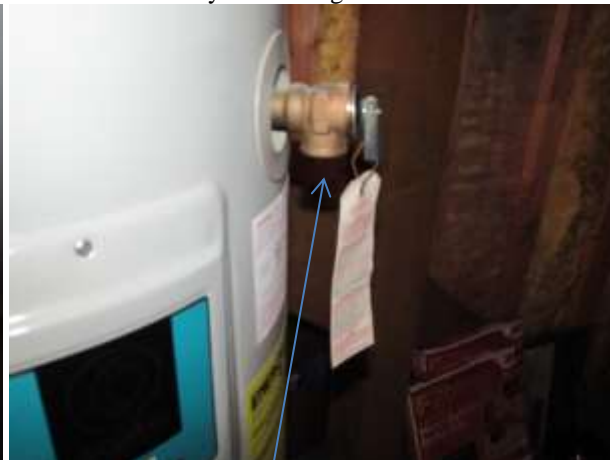
**Brand name:** State **Serial #:** B97758152  
**Type:**  Gas  Electric  Oil  Other  
**Unit Elevated:**  Yes  No  N/A  Tank/Piping corroded/leaking  
**Capacity:** 52 gallons **Approximate age:** 19 year(s)  
**Combustion Air Venting Present:**  Yes  No  N/A **Seismic restraints needed:**  Yes  No  N/A  
**Relief Valve:**  Yes  No **Extension proper:**  Yes  No  Missing  Recommend repair  
**Vent Pipe:**  N/A  Satisfactory  Pitch proper  Improper  Rusted  Recommend repair

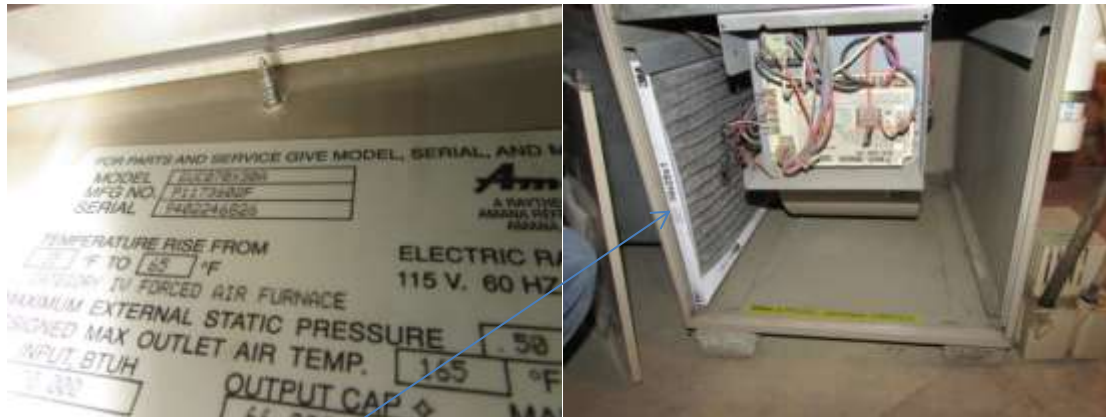
Note filter location.

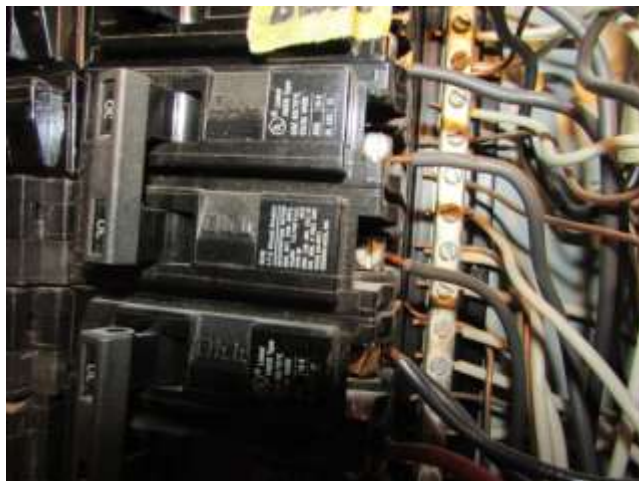
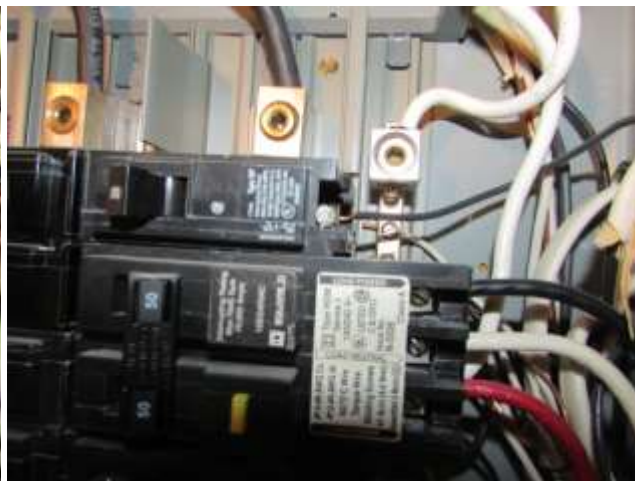
Panel not accessible  Not evaluated Reason: **INFO**

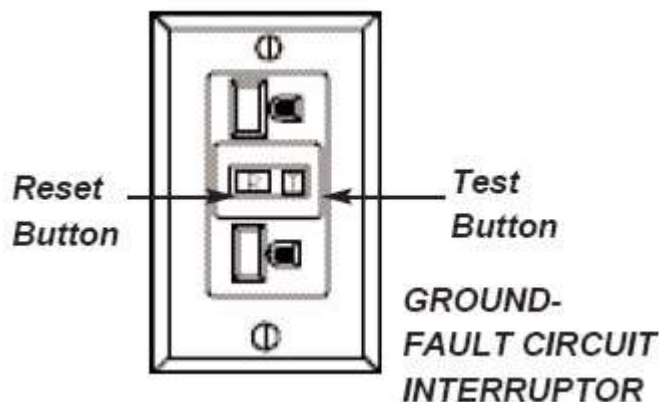
If you do have G.F.C.I.'s, it is recommended that you test (and reset) them monthly. When you push the test button, the reset button should pop out, shutting off the circuit. If it doesn't, the breaker is not working properly. If you don't test them once a month, the breakers have a tendency to stick and may not protect you when needed.
